Report number 17\_31704070

## TEST REPORT

### Environmental tests

**Procedure:** Water-tightness pressure test instruction RIVESTOP dated 27/03/2017.

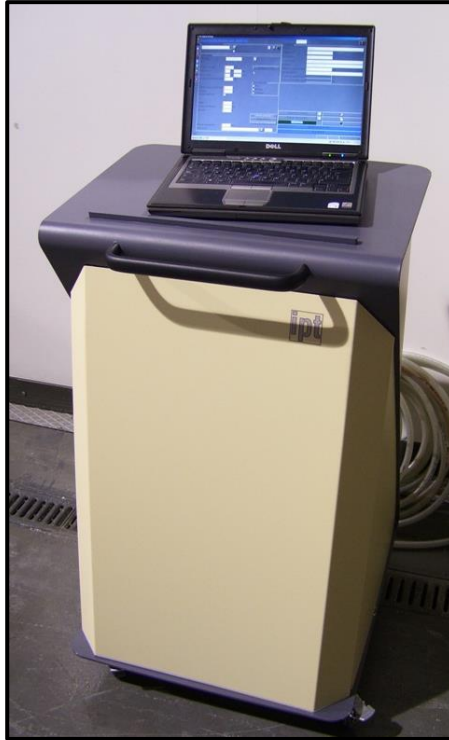
**Picture 1** IPT testing device

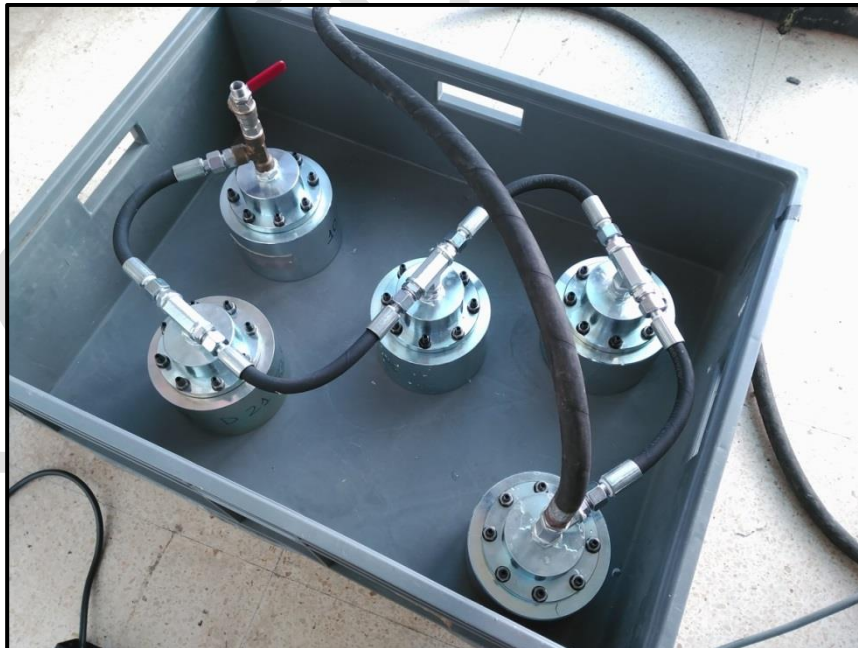
**Model D21x33PS:** Test pressure 5 bar, no leaks or changes detected during the tests. No movement or deformation of the RIVESTOPS was observed.

**Picture 2** Mounting and execution of tests on five D21x33PS samples
